STAND-PIPE ACCIDENTS AND FAILURES

IN THE UNITED STATES.

6-7627
A CHRONOLOGICAL RECORD OF ACCIDENTS TO AND
FAILURES OF WATER-WORKS STAND-PIPES
IN THE UNITED STATES, WITH FULL
DISCUSSIONS AND ASSIGNMENT
OF THEORIES.

WM. D. PENCE, C. E.,

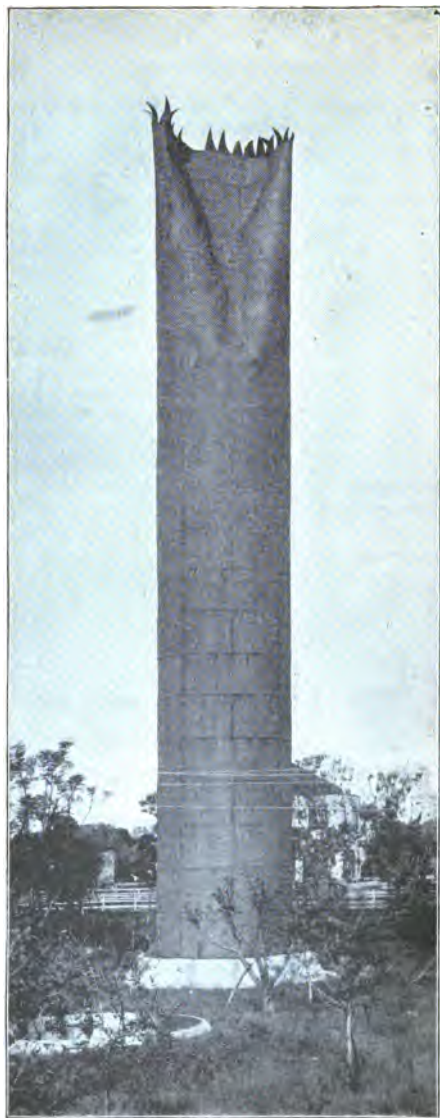
While at the time of this accident to the Victoria stand-pipe it was believed by some that the collapse had been largely due to the formation of a partial vacuum in the empty portion at the top, the fact that the yielding was on the windward side indicates that the cause is to be traced only to the direct impact of the wind. The empty portion swayed to and fro and vibrated very perceptibly before collapsing. The use of needlessly thin plates in the upper portion of the structure was plainly the chief cause of the failure, for the coincidence of an empty stand-pipe during a storm of unusual severity should have been provided for as a probable critical condition. Fig. 1 is a front and Fig. 2 a side view of the collapsed structure.

FIG. 1. FRONT OF COLLAPSED STAND-PIPE, VICTORIA,
TEX.

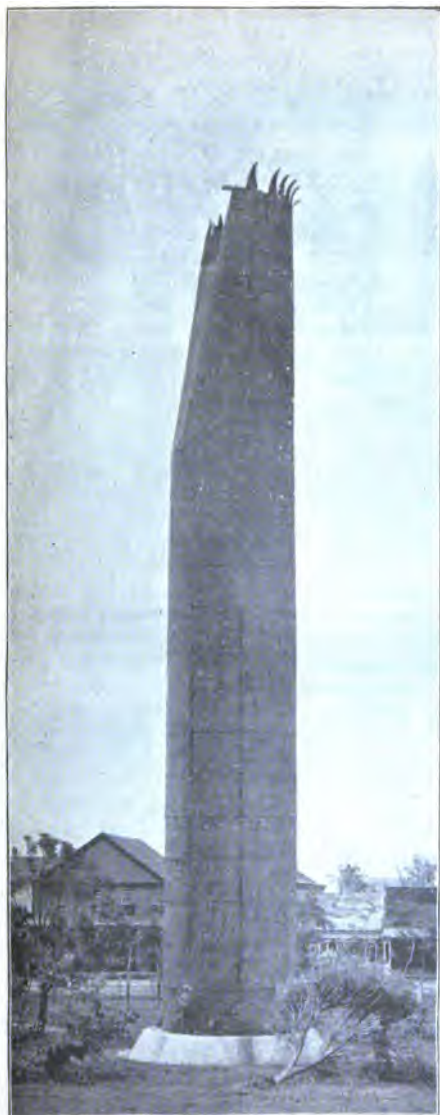
**FIG. 2. SIDE OF COLLAPSED STAND-PIPE, VICTORIA,
TEX.**

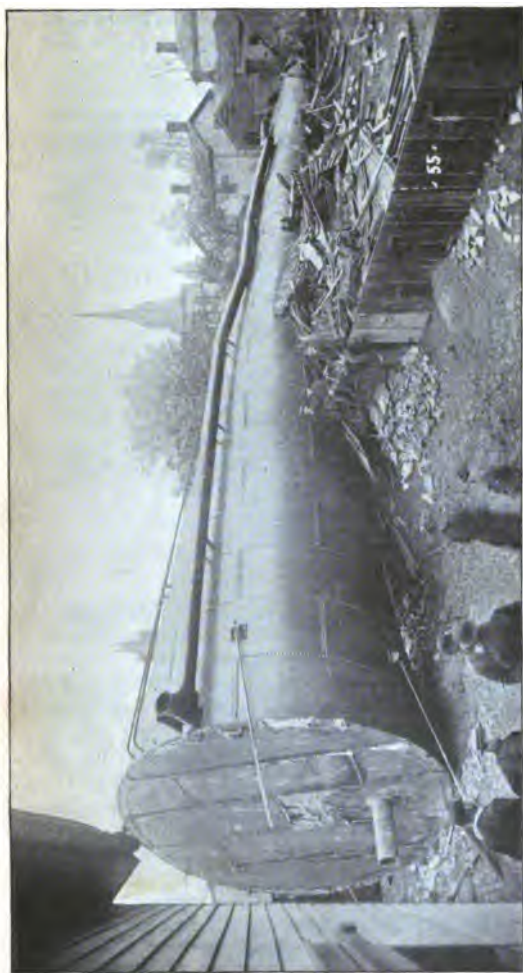
The 20 × 124-ft. wrought iron stand-pipe at Kankakee, Ill., partially collapsed and then overturned during a gale of wind at 9 a. m., Oct. 14, 1886. The tank was empty, having been completed only a week previous to the accident. The storm had begun early in the morning and rapidly increased in force until about the hour above mentioned, when the stand-pipe was first observed to sway slightly, then to lift from the foundation, first on one side and then on the other. An attempt to tighten the anchor rods was without success. In the meantime the sides of the stand-pipe contracted and expanded under the action of the severe gusts, until the windward side collapsed, forming a pocket which extended downward about 25 ft. from the top. With this suddenly increased pressure upon the collapsed top and the more and more violent blows upon the foundation due to the loosened anchor rods, a considerable section of the freshly constructed masonry crushed out on the leeward side, allowing the structure to fall in that

FIG. 3. VIEW OF WRECKED STAND-PIPE AT KANKAKEE, LOOKING NORTHWARD.

direction. The anchor rods on the windward side broke off, while the remainder straightened and pulled out of the masonry.

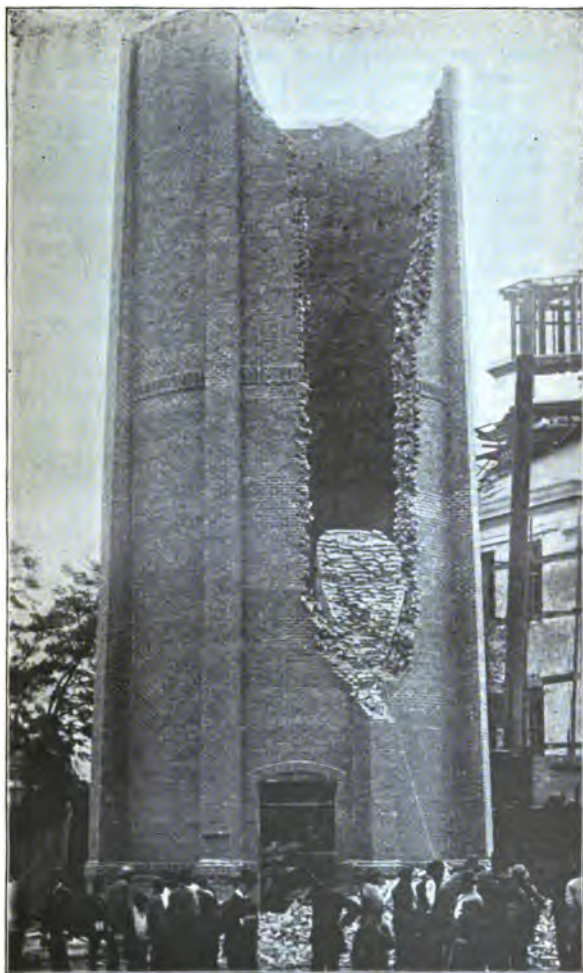
This stand-pipe, as first designed, was to consist of a 70-ft. brick tower supporting a wrought iron tank 25 ft. in diameter and 30 ft. high, the total height thus to be 100 ft. As planned and partly executed the brick tower consisted of an interior pier 6 ft. in diameter surrounded by an outer circular wall having eight buttresses. The brickwork was nearing completion when some bracing that had been placed between the center pier and the outer wall was removed. The pier fell, carrying with it a section of the outer wall, including one of the buttresses, as shown in Fig. 4. It was first thought

FIG. 4. COLLAPSED TOWER AT THOMASVILLE, GA., LOOK-
ING SOUTHEAST.

that the accident was due solely to vibrations caused in hoisting brick to the top of the pier, but it was afterward found that there had been some inequality in the settlement of the foundations which may have had some influence in causing the failure. However, this inequality in settlement may have been one of the effects rather than a cause of the failure. The tank had not been erected at the time of the failure, and consequently the damage to property was limited to the brickwork itself. Four men, one of whom was the contractor, were killed and four others seriously injured in the accident.

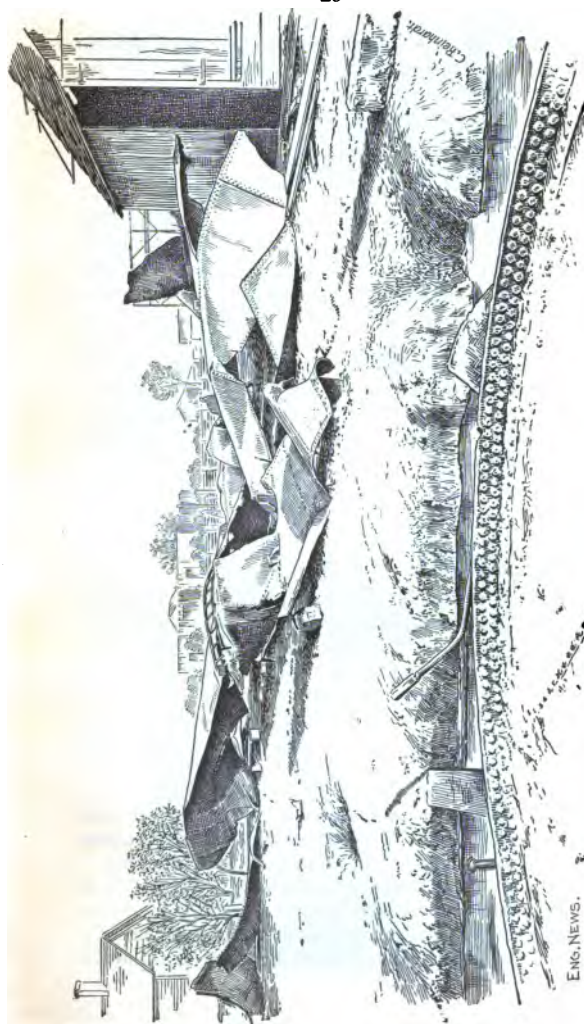
FIG. 5. TEMPLE STAND-PIPE, LOOKING EAST AT PORTION OF LOWER PLATES.

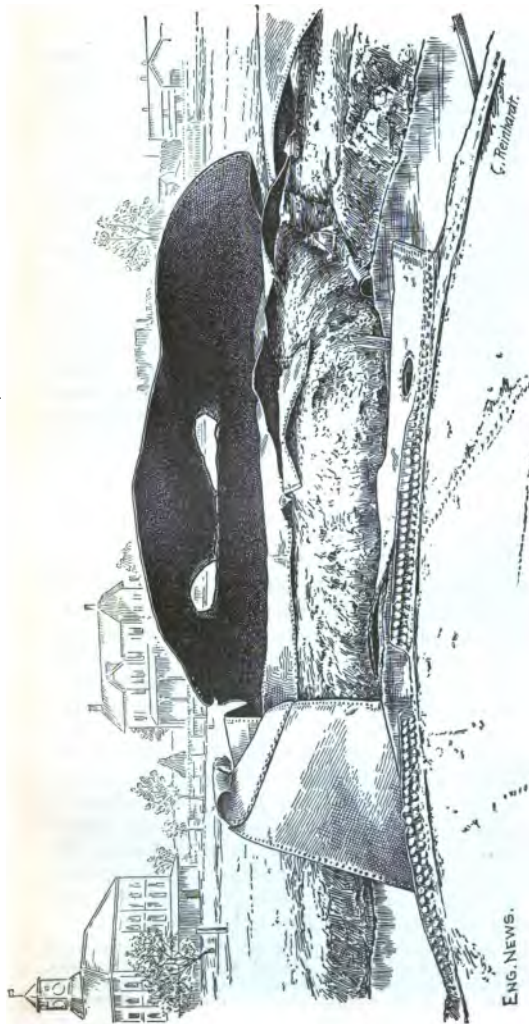
FIG. 7. TEMPLE STAND-PIPE, LOOKING WEST THROUGH UPPER PORTION.

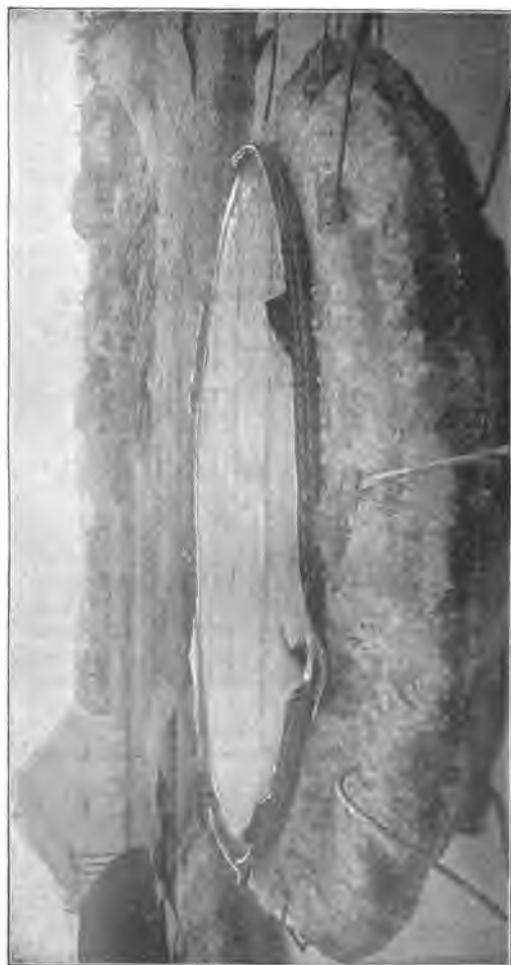
The tensile strength was 75,000 lbs.; but they were so brittle that when the 2½-in. wide test specimens, which were sheared off the sheets and slightly bent in the shearing were straightened in the rolls, several of

FIG. 8. INCISION IN BED PLATE OF TEMPLE STAND- PIPE.

them broke short off, like cast iron. The computed stress per square inch of net section in a bottom ring vertical seam was only about 17,000 lbs. when it failed.

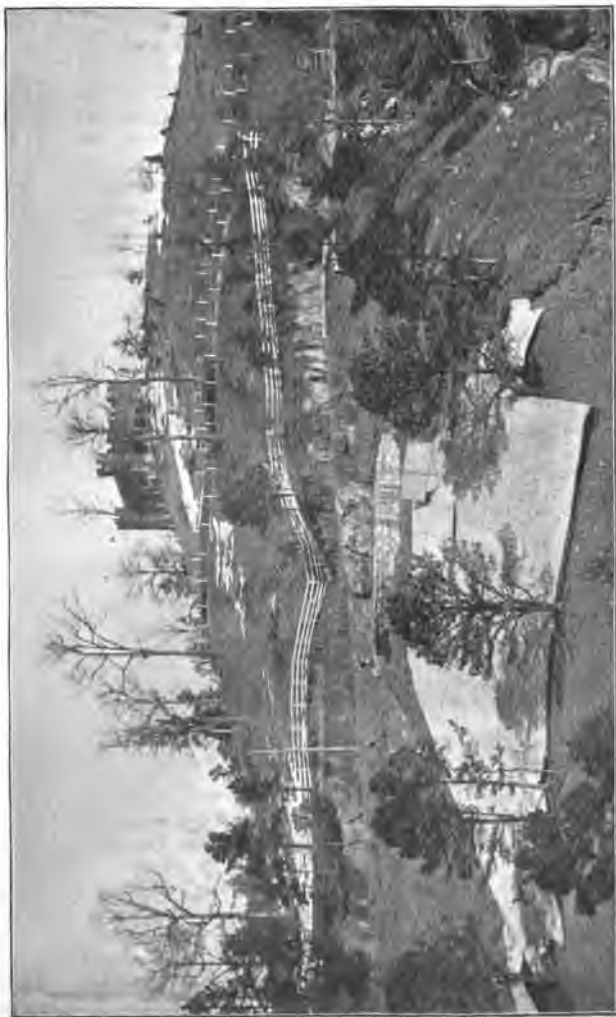
The relatively constant stage of water in the stand-pipe due to its restriction to the demands of fire service would allow the ice to form a tube having an equal thickness from the base to the level of the water. During the few warmer days preceding the accident, the heat of the sun must have caused the ice to melt more or less where it came in contact with the metal shell on the south half of the stand-pipe, and as the junction of the ice with the bedplate was doubtless watertight, for the reason above stated, the water trickling down

FIG. 10. VIEW OF STAND-PIPE FAILURE AT ASHEVILLE, N. C., LOOKING NORTH.

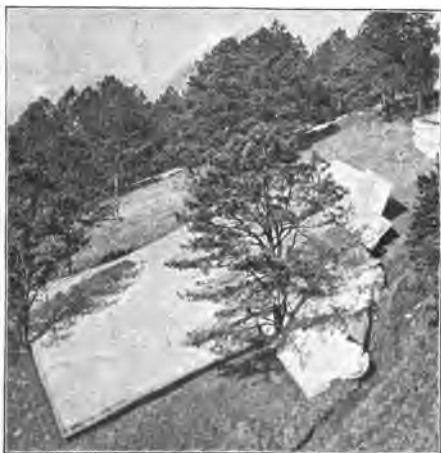
would fill the melted space to a level of probably nine-tenths of the total height of the ice tube. With the fall in temperature on the night of the failure, the pocket of water would probably re-freeze at the top first, after which the remaining water, being confined, would develop enormous energy, retaining its liquid form except as available space was gained by compressing the ice tube or extending the plates of the stand-pipe, as in the familiar

FIG. 11. VIEW OF STAND-PIPE FAILURE AT ASHEVILLE, N. C., LOOKING NORTHWEST.

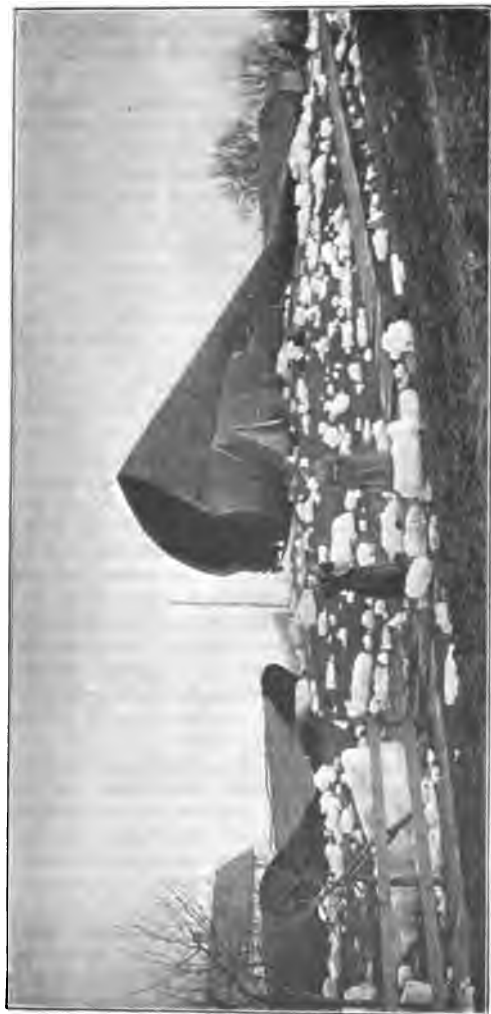
During the formation of the ice walls the thickness was doubtless greater upon the north than

FIG. 12. VIEW OF COLLAPSED STAND-PIPE AT MARYVILLE, MO., LOOKING SOUTHWEST.

upon the south side of the stand-pipe, and this difference in thickness was probably materially increased during the several days of higher temperature which preceded the accident. Moreover, during the latter period the influx of freshly pumped water must have melted the ice for some distance above the base, and it is not improbable that the entire body of ice had been thawed loose from the metal shell through the influence of the solar heat, so that with the stand-pipe nearly or quite full, the mass of ice would be buoyed up against or perhaps slightly above the top stiffening angle. With these conditions existing on the evening preceding the failure, the small consumption of water during the night might easily have permitted the ice-tube to freeze fast in the above described position with the excessive fall in temperature. The melting loose under the reversed conditions of the following morning was a natural consequence, and, had the stand-pipe been full or nearly so, no signs of it would have been revealed. However, if the enormous energy stored in the suspended mass of ice (weighing probably not far from 1,000,000 lbs.) be considered in connection with the height of the water at the time of the accident (about 35 ft. below the top), the strains due to the fall above described would seem amply severe to cause the destruction of the stand-pipe. The initial rupture upon the south side might have been due either to the decreased thickness of the ice or to the blowing out of the inlet pipe connection.

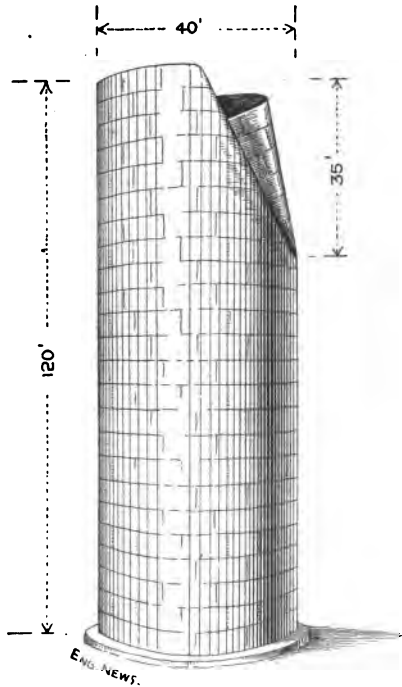
of the material and workmanship was strikingly displayed when, upon the day following the accident, the stand-pipe was again pumped full and the indented portion was sprung into shape. A

FIG 13 VIEW OF INDENTED STAND-PIPE, EAST PROVIDENCE, R. I., SEPT. 7, 1893.

single leak was found at the lower extremity of the bent plates, being due to a few strained rivets which were replaced, leaving the structure apparently "as good as new."

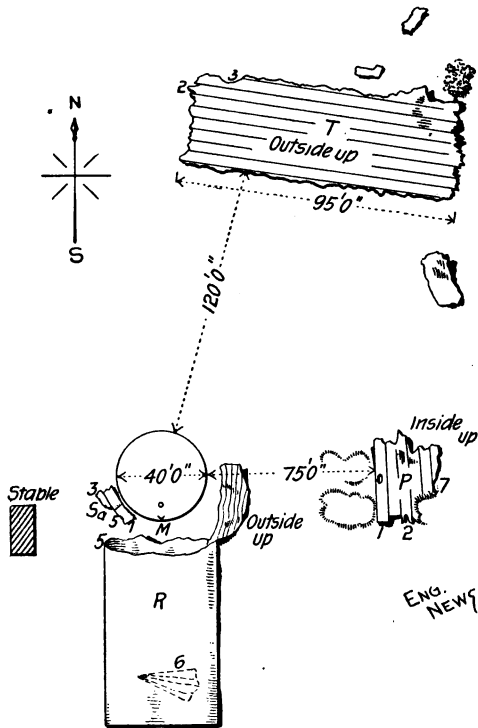
above quoted, Mr. Leland is of the opinion that the first rupture took place at a point about 55 ft. above the base, in support of which he refers to

FIG. 14. SKETCH PLAN OF WRECKED STAND-PIPE AT EAST PROVIDENCE, R. I.

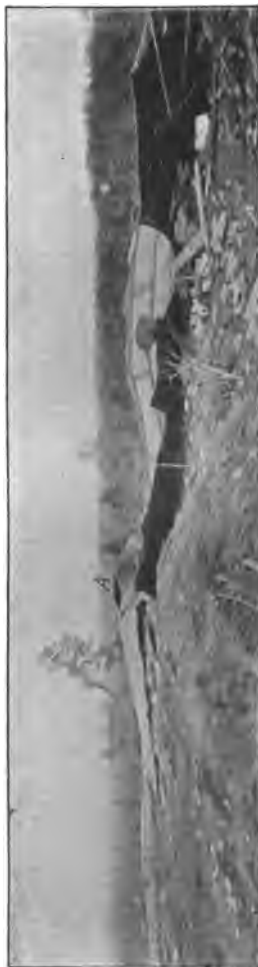
the photographic view, Fig. 15, of Piece T, and calls particular attention to Point A, which was originally located in the 11th course on the southwest side, as follows:

This place presents the appearance of having re-

FIG. 15. PORTIONS OF WRECKED STAND-PIPE, EAST PROVIDENCE, R. I.

ceived a terrific concussion of some kind from the inside. The fractures of the plates at this point radiate in all directions, with the edges rolled outward.

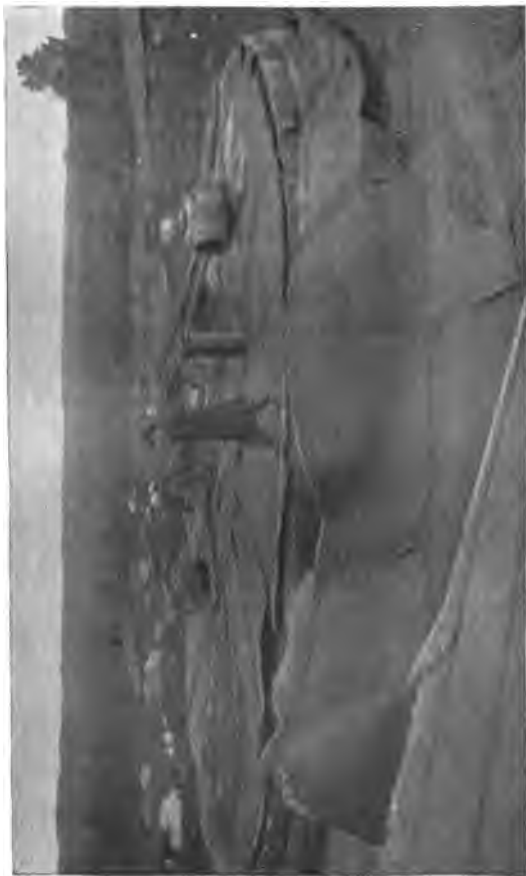
FIG. 16. GENERAL VIEW OF EAST PROVIDENCE STAND-PIPE FAILURE.

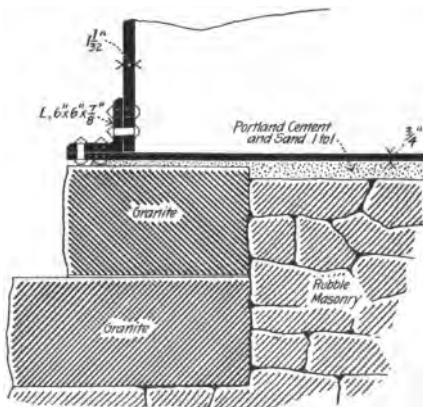
It has been charged that the cement bed under the bottom of the tank was deficient about the

FIG. 17. SECTION SHOWING BOTTOM OF EAST PROVIDENCE STAND-PIPE AND TOP OF FOUNDATION.

edges, but Mr. Leland shows in Fig. 17 the details of the top of the foundation, and states that the bedplate had a firm bearing throughout, it having been intended to point up around the base after the stand-pipe had been filled and had found its bearing in the bed of dry cement and sand.

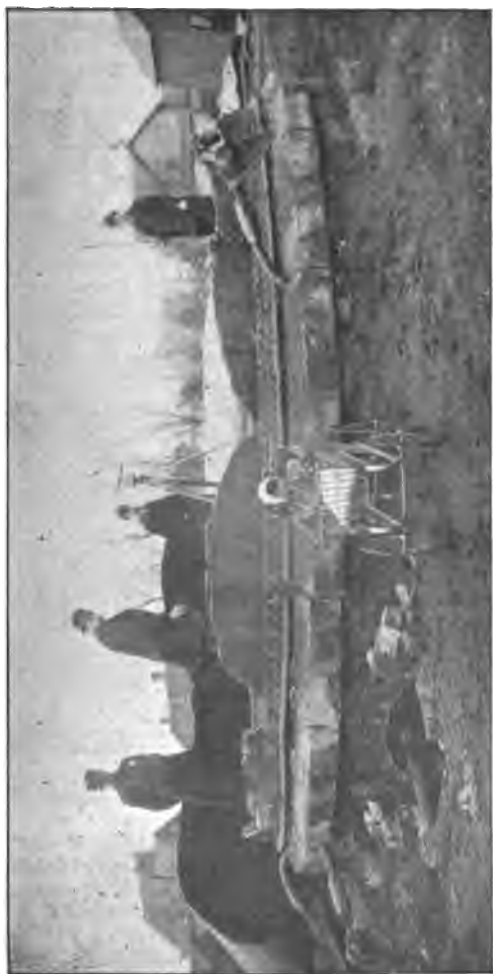
FIG. 26. WRECKED STAND-PIPE AT PEORIA, ILL., LOOKING NORTHEAST.

The view, Fig. 26, looking northeast, shows the base and foundation of the stand-pipe and the location of the inlet. The child in the foreground was rescued uninjured from the cottage, which was wrecked by the large piece, No. 24. The portion of the pipe shown partially straightened out at the left of this view is the seventh course. Fig. 27 shows the stand-pipe above the lower and shattered courses, looking a little south of east, with the foundations in the distance. The blocking was used to raise the wreck in the search for bodies.

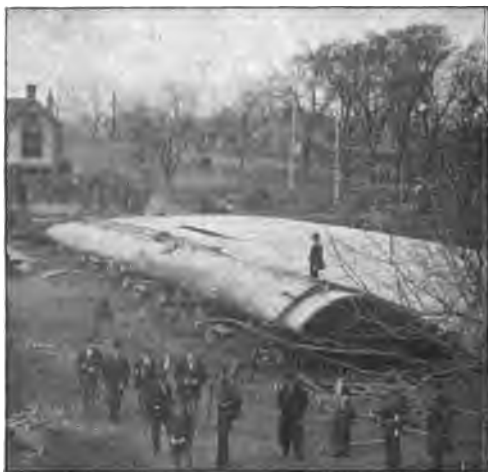
FIG. 27. FLATTENED PORTION OF PEORIA STAND-PIPE.

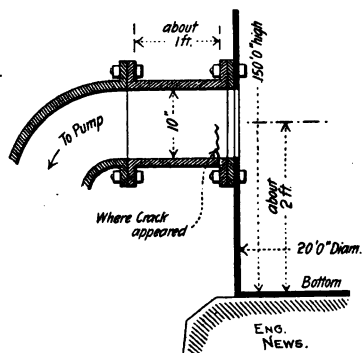
FIG. 28. BREAK IN SUPPLY MAIN TO STAND-PIPE AT BAYSHORE, L. I.

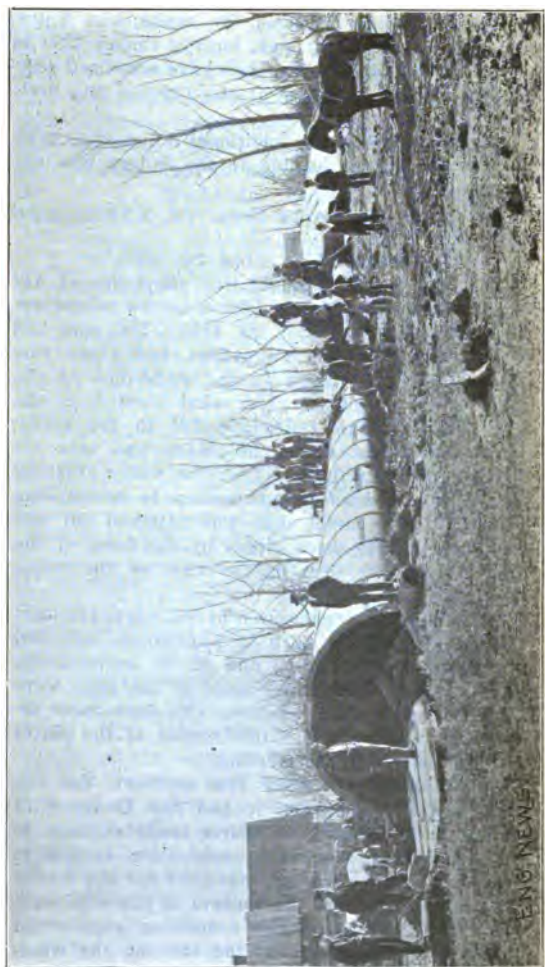
In seeking a cause for this accident, the evident similarity between it and the Dodge City failure in all essential features leads at once to the belief that the same explanation applies to both. The theory already assigned for the Dodge City failure assumed the rupture of the windward guy or guys, so that the remaining guys acted to augment the strain at the base on the windward side of the stand-pipe, where a flaw prob-

FIG. 29. VIEW OF STAND PIPE RUINS AT ANTHONY, KAN., LOOKING SOUTHEAST.

ably existed. While it must be granted that the increased number of guys at Anthony tends somewhat to discredit the theory as stated, it is here adopted as being the most plausible. It is very certain that the wind could not have overturned the nearly full tank weighing not far from 1,000,000 lbs. An inspection of the view, Fig. 29, indicates that the initial fracture occurred on the windward side in the line of single riveting at the edge of the bedplate.

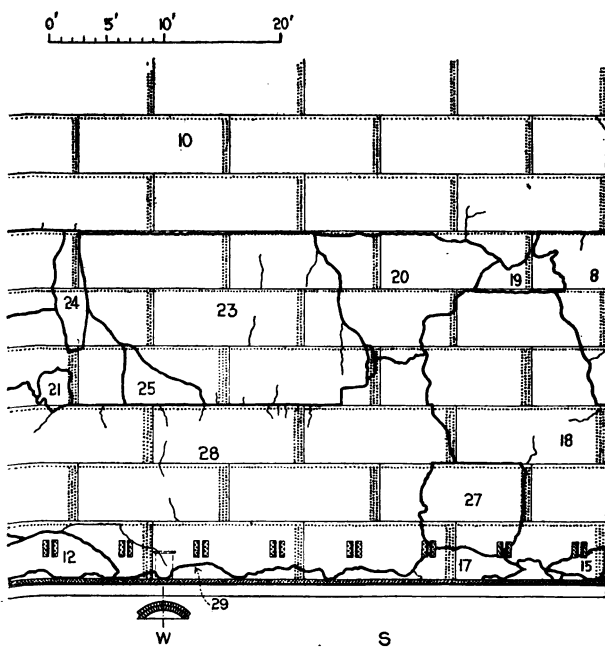
Lower Courses of Stand-Pipe, Showing Original Position of Fragments.

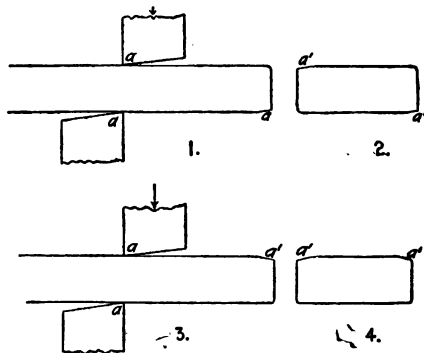
FIG. 33. EFFECT OF SHEARING SOFT STEEL.

ber, 1894), and will show the extent and character of injury caused by shearing soft steel:

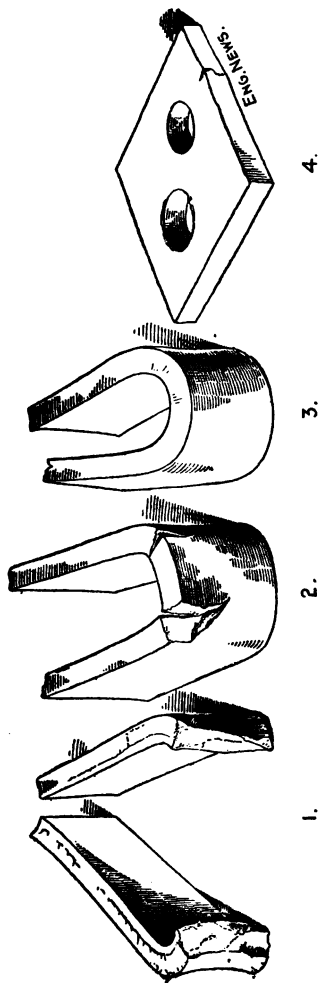
FIG. 34. SAMPLES 1. 2. 3 AND 4.

bottom die in punching (corresponding to the indentation "a," Fig. 33, in shearing) is on the outside of the curve, and in the very worst condition to withstand the action of the bending rolls.

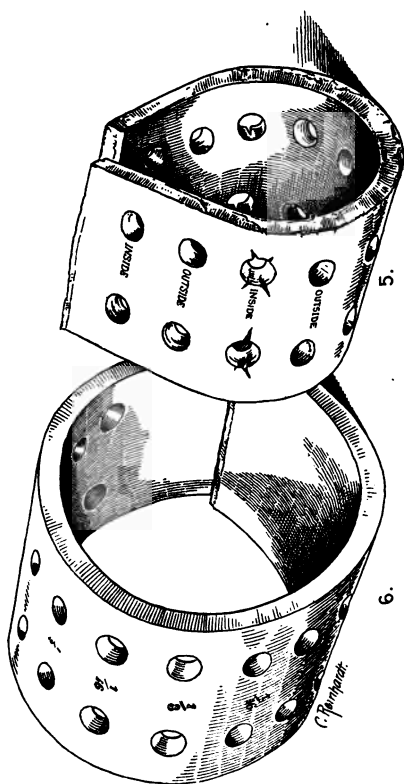
FIG. 35. SAMPLES 5 AND 6, $\frac{5}{8}$ -IN. OPEN-HEARTH STEEL BOILER PLATE.

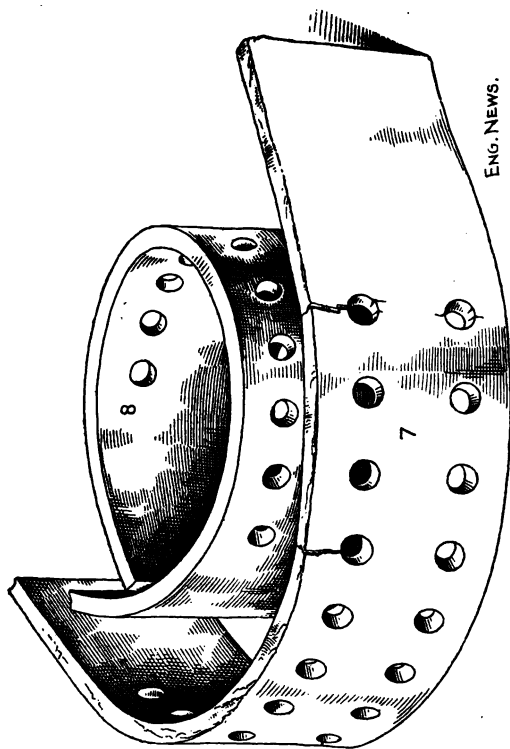
Two pieces of Bessemer steel plate, $\frac{1}{2}$ in. thick, were sheared to 6×36 ins., and punched the same as before. They are shown by the sketch, Fig. 36. Sample 7 has sheared edges and punched holes, while Sample 8 has planed edges and reamed holes. These pieces were bent in bending rolls, but when Sample 7 reached a curve of 20 ins. diameter, the plate had cracked in four places from the sheared edge "a," Fig. 33, to the punched holes. In three cases the holes were punched from the inside, and in the

FIG. 30. SAMPLES 7 AND 8, $\frac{1}{2}$ -IN. BESSEMER STEEL PLATE.
